DEPARTMENT OF TRANSPORTATION

Contract #: 04-0120F4Cty: SF/ALA Rte: 80 PM: 13.2/13.9File #: 69.28**WELDING INSPECTION REPORT****Resident Engineer:** Siegenthaler, Peter**Address:** 333 Burma Road**City:** Oakland, CA 94607**Report No:** WIR-022184**Date Inspected:** 28-Mar-2011**Project Name:** SAS Superstructure**OSM Arrival Time:** 700**Prime Contractor:** American Bridge/Fluor Enterprises, a JV**OSM Departure Time:** 1900**Contractor:** Zhenhua Port Machinery Company, Ltd (ZPMC), Changxing Island **Location:** Shanghai, China**CWI Name:** Zhu Zhong Hai**CWI Present:** Yes No**Inspected CWI report:** Yes No N/A**Rod Oven in Use:** Yes No N/A**Electrode to specification:** Yes No N/A**Weld Procedures Followed:** Yes No N/A**Qualified Welders:** Yes No N/A**Verified Joint Fit-up:** Yes No N/A**Approved Drawings:** Yes No N/A**Approved WPS:** Yes No N/A**Delayed / Cancelled:** Yes No N/A**Bridge No:** 34-0006**Component:** OBG Segments**Summary of Items Observed:**

On this date Caltrans OSM Quality Assurance (QA) Inspector, Dan Hernandez was present during the times noted above to observe the fit up, welding and related activities associated with the fabrication of the San Francisc

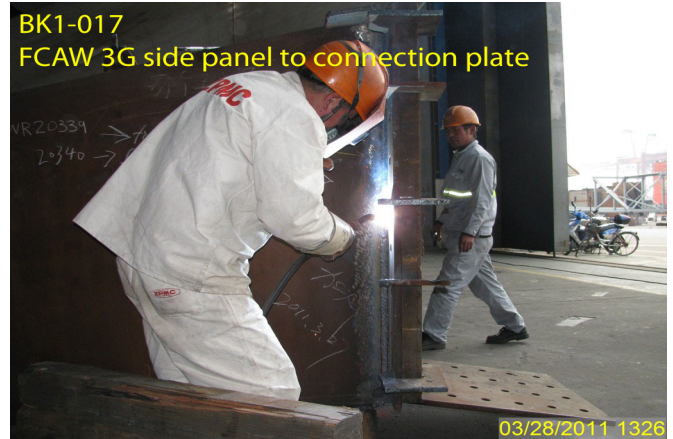
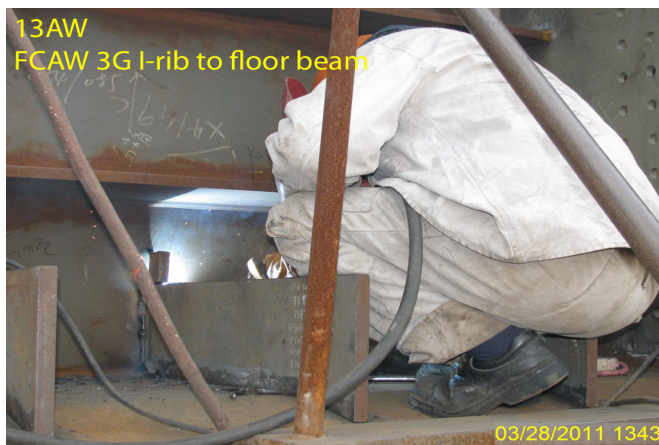
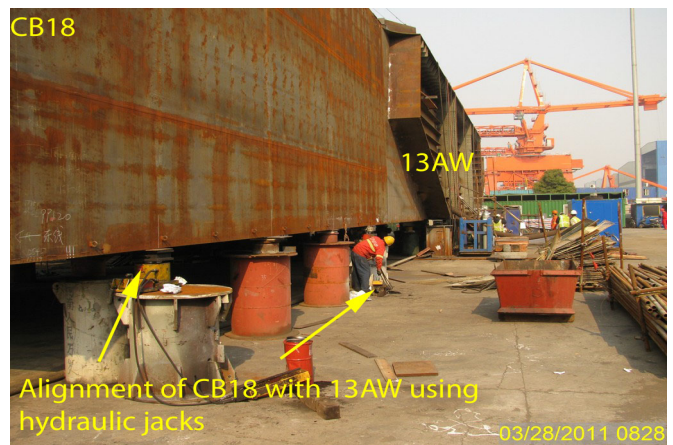
This QA Inspector observed Shielded Metal Arc Welding (SMAW) in progress of a fillet weld joint. The Weld joint is designated SEG3001AD-018, Service Platform Bracket to Side Plate. The welder is identified as #067752 and was observed welding in the 4F (overhead) position using approved Welding Procedure Specification WPS-B-P-2114-FCM-1.

This QA Inspector observed Flux Cored Arc Welding (FCAW) in progress of a Complete Joint Penetration (CJP) weld joint. The Weld joint is designated SEG3013C-059, Bottom Plate I-rib stiffener. The welder is identified as #048433 and was observed welding in the 3G (vertical) position using approved Welding Procedure Specification WPS-B-T-2233-ESAB.

This QA Inspector observed Flux Cored Arc Welding (FCAW) in progress of a Complete Joint Penetration (CJP) weld joint. The Weld joint is designated BK1-017-007, Side Panel to Connection Plate. The welder is identified as #040367 and was observed welding in the 3G (vertical) position using approved Welding Procedure Specification WPS-B-T-2233-ESAB.

This QA Inspector observed drilling of bolt holes in the Side Panel for the segment to CB splice Plate connection at panel point 112.

This QA Inspector observed alignment of CB18 with Segment 13AW with the use of hydraulic jack systems.
